# FIRE HALL NO. 15

## Combining heritage and contemporary function

Researched and written by Katie Filek, Vancouver Heritage Foundation

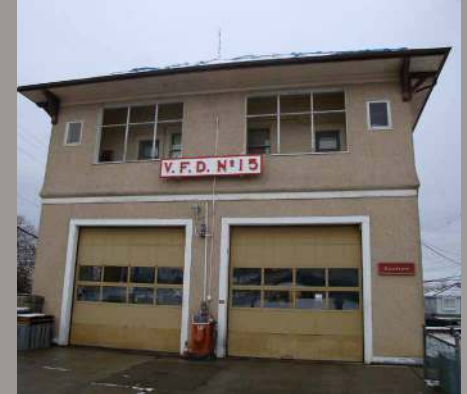
The hall in 2009, prior to restoration

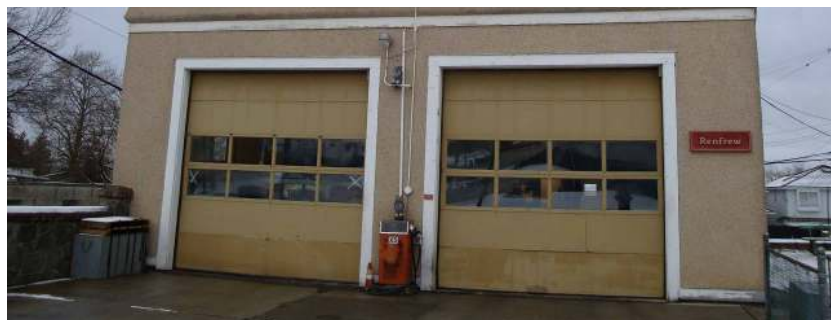
■ Fire bays with garage doors in 2009, prior to restoration  
*Photo courtesy of HCMA*

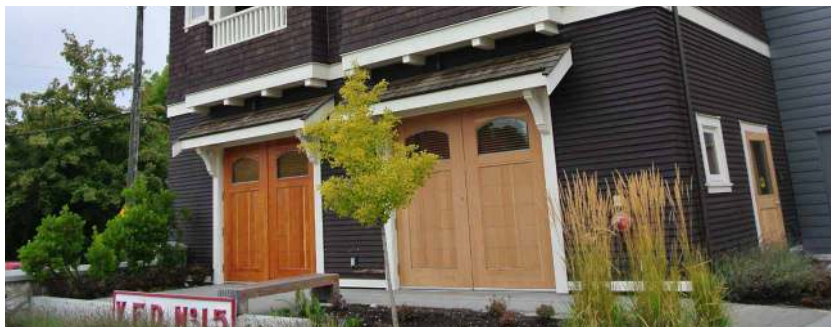
■ Restored front of fire hall with new fire bay doors (the doors on the left are still functioning, and open to a community meeting room)

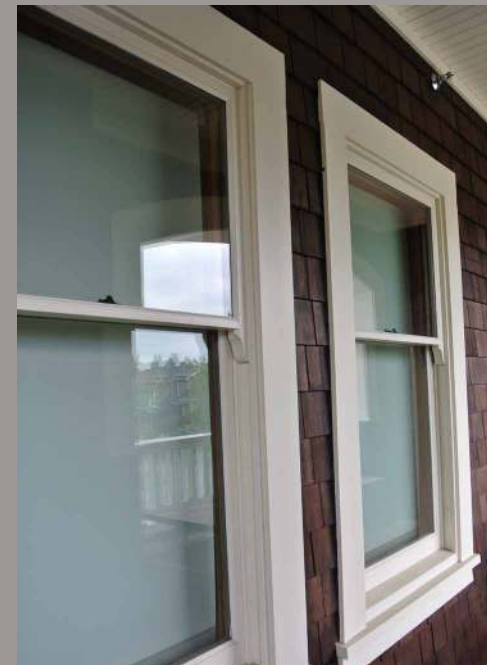
■ The dormitory's original windows were replaced with double-glazed units in order to increase energy efficiency and reduce noise transmission. Parts of the original wood frames were saved and repaired where possible.

Although the existing single panes were found to be in generally good condition, the decision was made to install double-glazed units in order to ensure entirely comfortable, quiet living conditions so that firefighters can sleep, even in the day when necessary. This is an example of where function took precedent over preserving historic material.

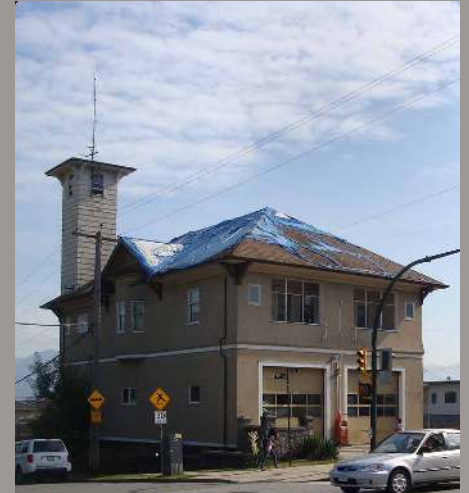
it was physically failing. Firefighters were using tarps to keep rain out of openings in the roof and it was at one point deemed unsafe for occupation. The fire hall was therefore viewed by many as unsuitable for continued use and even for rehabilitation. In 2007, the 1913 building was recommended by the City for demolition and replacement with a new hall. However, following community outcry and a subsequent vote by City Council to retain the building, the parties involved in the project's design were able to find a way to

■ The fire hall prior to its restoration, with blue tarps covering the roof where its surface was failing.

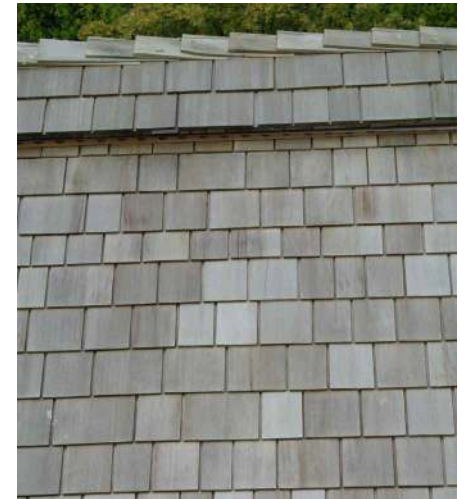
■ New cedar shakes were installed on the 1913 building's roof - a decision that is not standard practice in new construction projects, but is important in restoring the building's heritage character

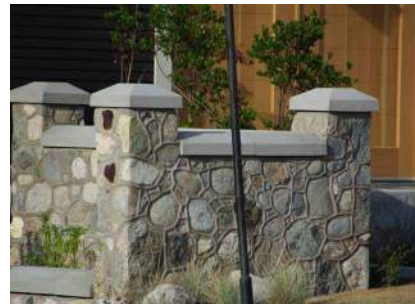
The fire hall's original rock wall, running parallel to Nootka St, was an important heritage landscape feature on the site.

Although it looked to be in good condition, the wall was found to be in need of remediation and was ultimately rebuilt. Many of the original stones were reused.

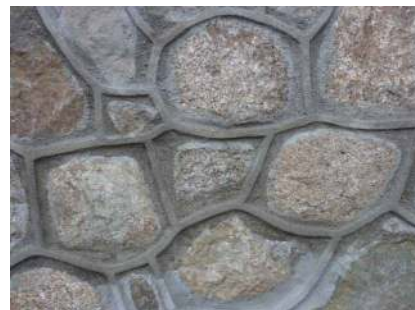
The essentially new wall is built around a concrete core, meaning it is more seismically sound.
