# Restoring a BC Mills Prefab House in Strathcona

521 Hawks Street, Heritage B, 1903 construction, 1904 water hookup.

VANCOUVER  
HERITAGE  
FOUNDATION

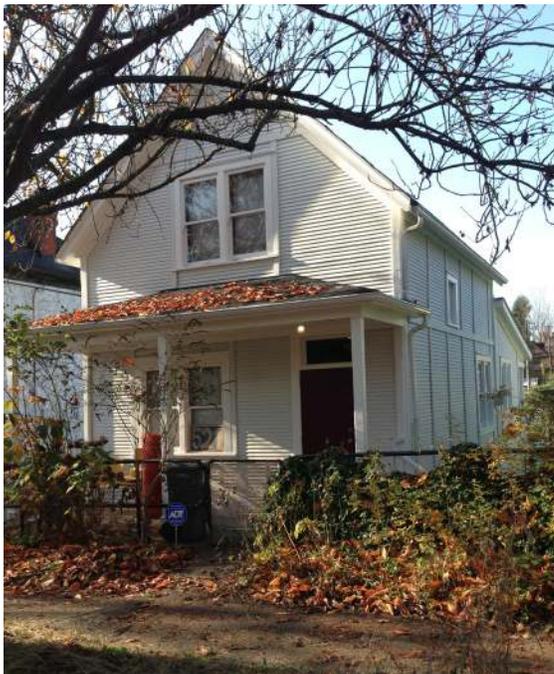
Paige Gardiner was a fan of Strathcona and its old homes and had long wanted to be a resident. When she heard about a listing before it hit the MLS in 2007, she jumped. Paige was about to embark on a long road to restore a Strathcona home to its former glory (restored home pictured left).

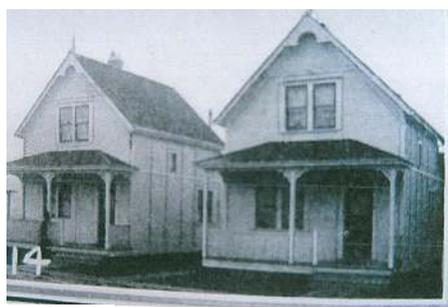
Bottom Left: Archival Images of original home. The lower image from the 1970's shows the original porch missing and the streets have been leveled.

suddenly below street level. It required some back and forth with the city for permission to raise the house 3 feet to be level with the road. With that permission attained the home was raised for a cement foundation to be poured. The house was sound when the Gardiners bought it in 2007 but the foundation posts were on dirt. The house was constructed using balloon framing meaning the floor joists are hung from the wall framing.

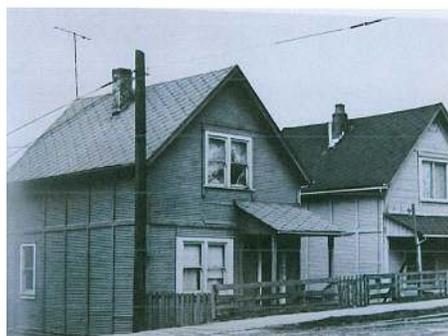
Bottom Right: Porch restoration has started

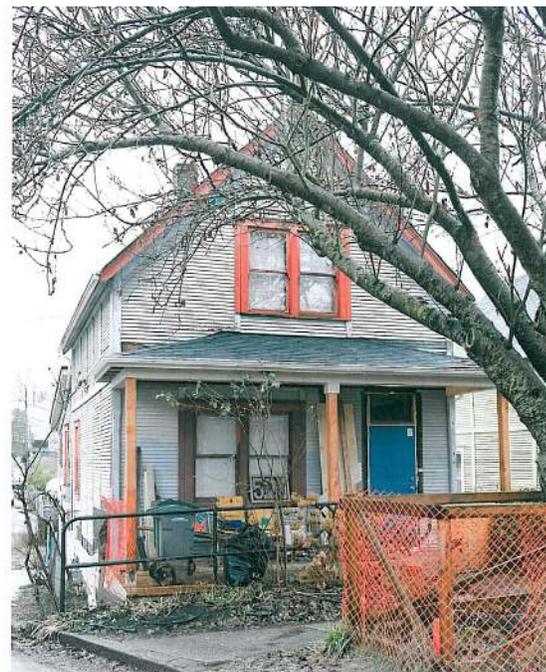
Top Left: After restoration of porch, siding and re-painting

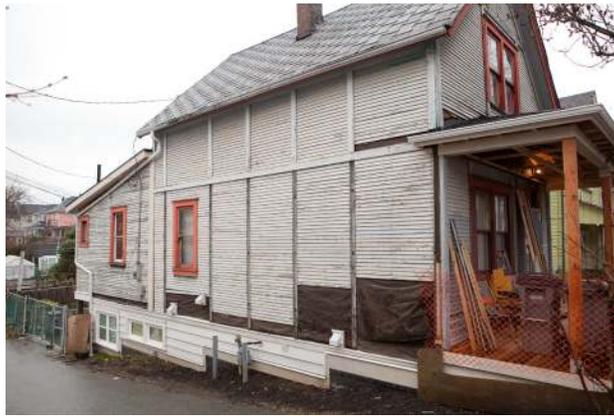
Top: Damaged siding in the process of replacement, front porch restoration is underway

After raising the house and fixing the kitchen roof, two new replica wood windows were installed in the new basement, and Paige started work on the siding in 2012. Much was in poor condition and needed heavy scraping or replacement prior to painting. The siding is tongue-and-groove that sits in dadoed vertical posts in independent panels. Each panel unit would come from BC Mills assembled, and the units would be bolted to the balloon framing. Then they were bolted to each other, and covered by trim. This made the restoration of the siding especially tricky. When one piece of board was in poor condition and needed replacing, the entire panel was involved.

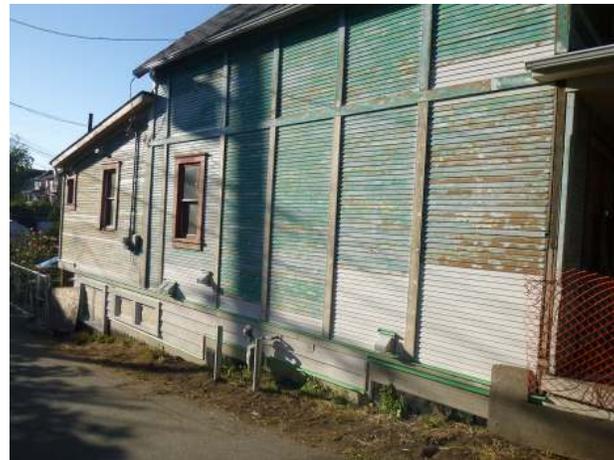
Centre: Some siding and trim has been replaced, damaged pieces are repaired and the entire wall sanded in preparation for paint

replacement and was custom milled to match. Paige manufactured matching replacement trim and bead trim for the exterior on site with a router and table saw. The prior residents had stripped all interior walls and floors to the original wood, so that job was already done. Since starting Paige has keenly developed an appreciation for retaining original fabric!

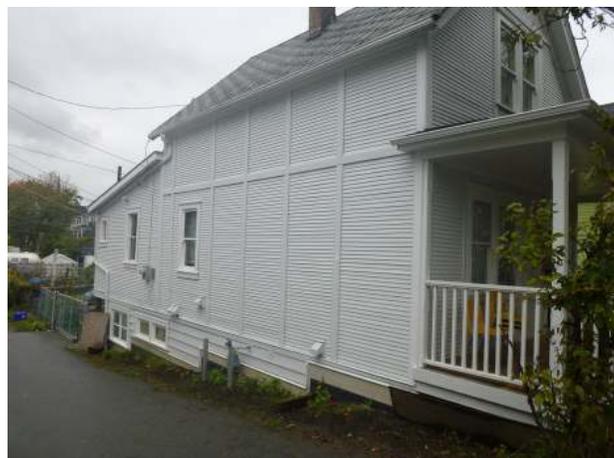
Bottom: Painting has been completed and porch is fully restored
