3500 Willow St.

Building at a Glance

Energy Efficiency Retrofits

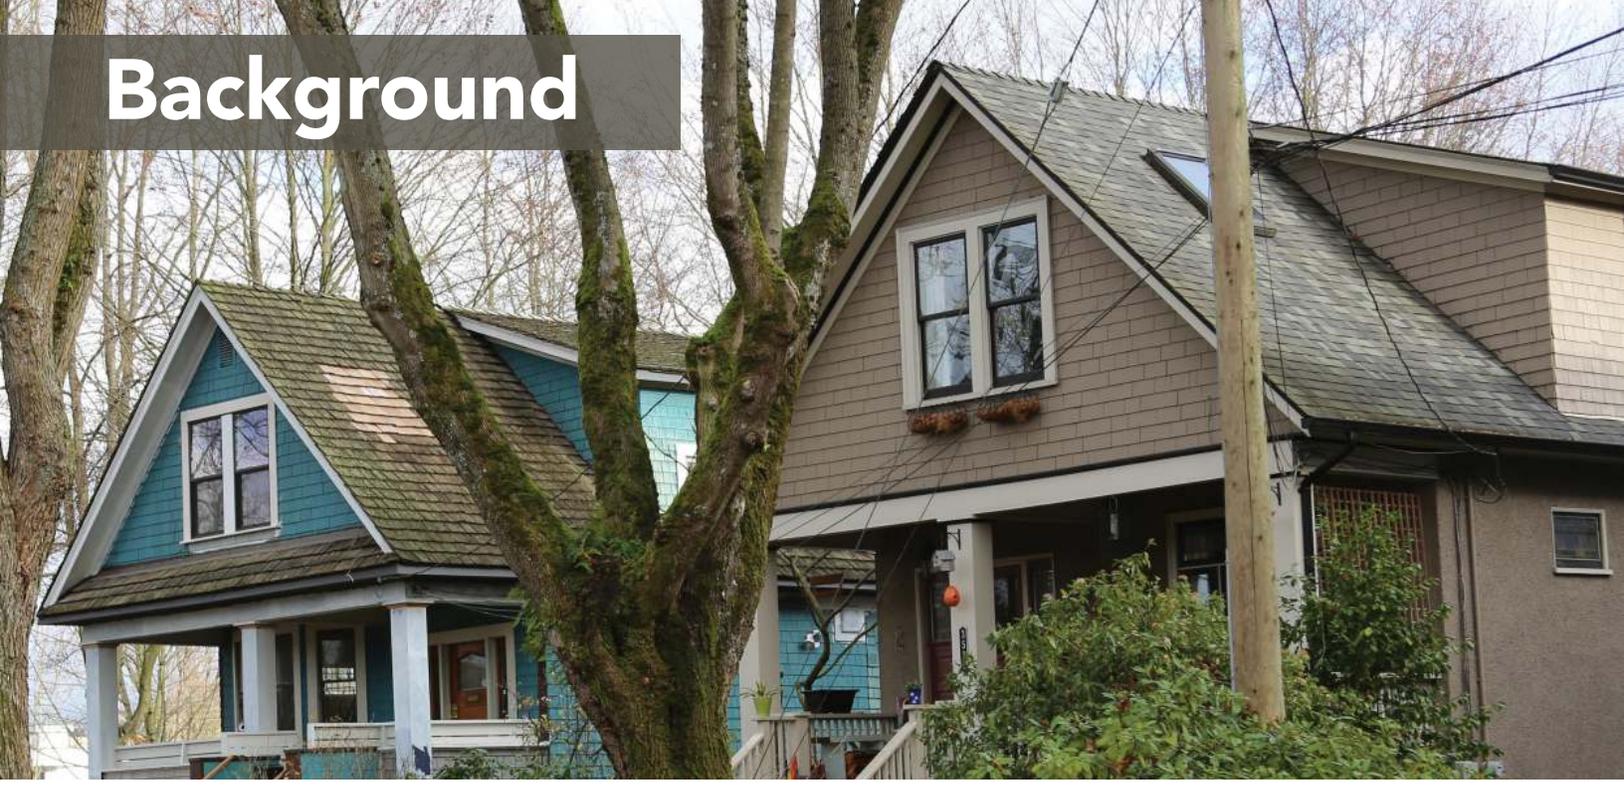
3500 Willow St. and its neighbour (above), built in the same early vernacular style, potentially after a local pre-fabricated design.⁽²⁾

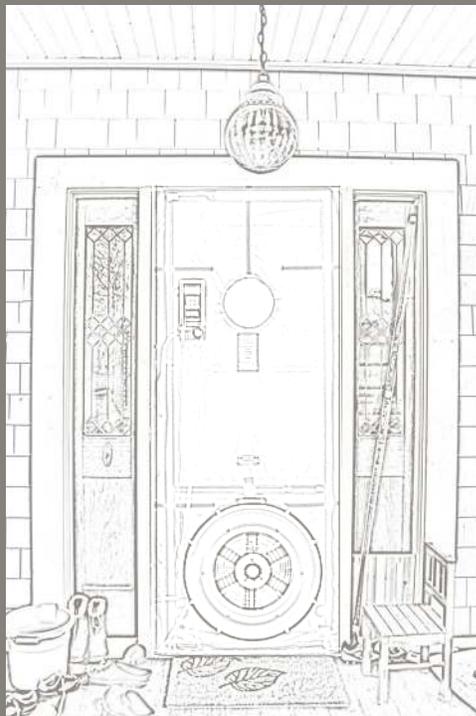
Blower Door Test

A blower door test is used to measure air changes within a structure. A powerful fan is mounted to the main door and pulls air out of the house, lowering the internal air pressure. Exterior air then flows into the house through openings to fill the lower pressure environment. At this point the house can be inspected for air leakages with a smoke pencil while a calibrated gauge measures the ACH and ELA.⁽³⁾

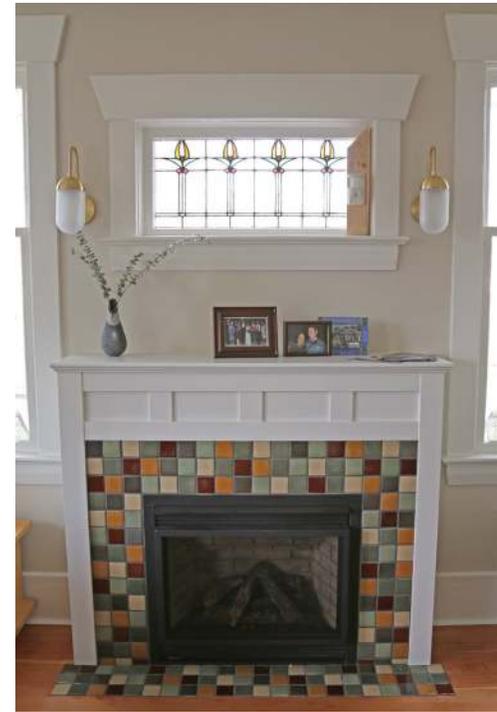
New EnerGuide gas fireplace (right). Although not original to the house, the fireplace echoes the original interior features. Note how the tile colours mirror the original stain glass windows above.

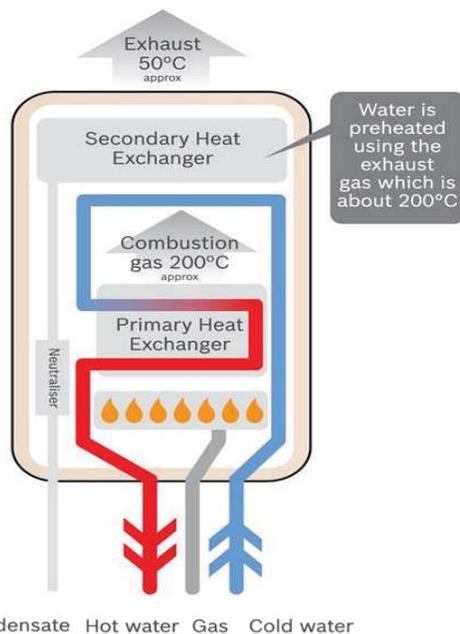
The Gantts replaced their water heater with a 0.95 energy factor condensing tankless hot water heater (far right). Rather than storing hot water, this on-demand system only heats water when you need it, using high inputs of gas.⁽⁵⁾

efficient models, choosing a compact furnace with an Annual Fuel Utilization Efficiency of 96% and a tankless condensing hot water heater with a 0.95 energy factor.

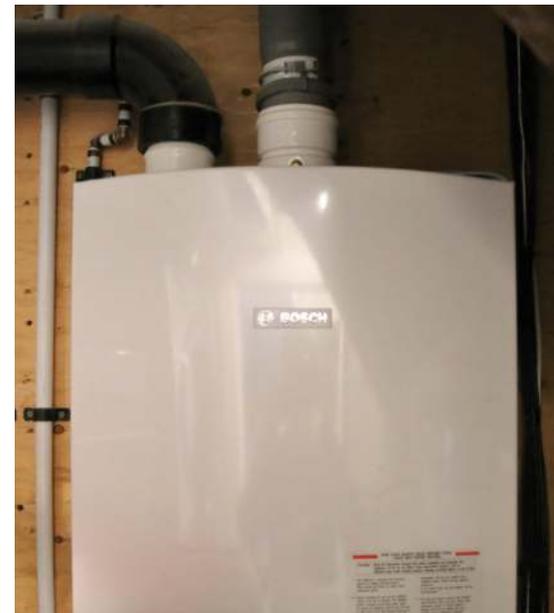
The diagram (right), courtesy of Bosch, illustrates how an on-demand hot water heater is made more efficient by the use of condensation produced by combustion gases. The system uses the excess heat created by the condensation to reduce the amount of gas needed to heat incoming water.⁽⁶⁾

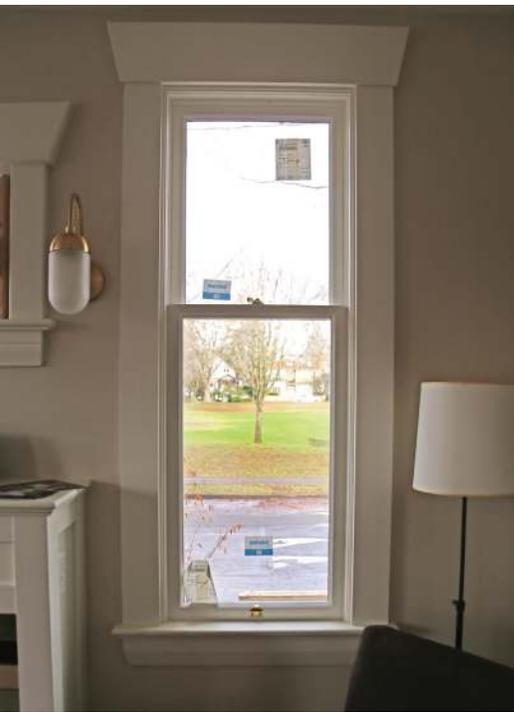
Two custom crafted heritage-style wood frame windows were made for the Gantts' living room to match the originals in the room's prominent bay window.

Most of the home's original windows had been previously removed, so the Gantts chose to install thermal units throughout the home. Two new wood windows were installed in new openings on either side of the fireplace, complimenting the original bay window. As the home sits on a corner, they were permitted to add side windows facing the street. Original

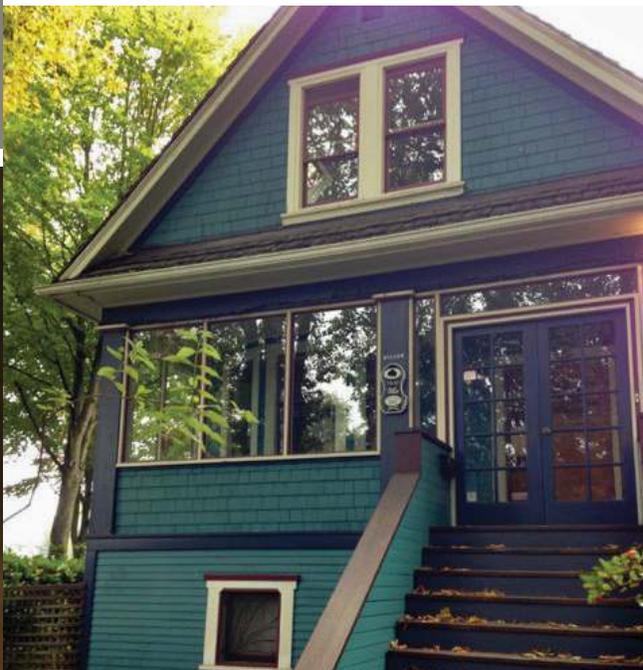
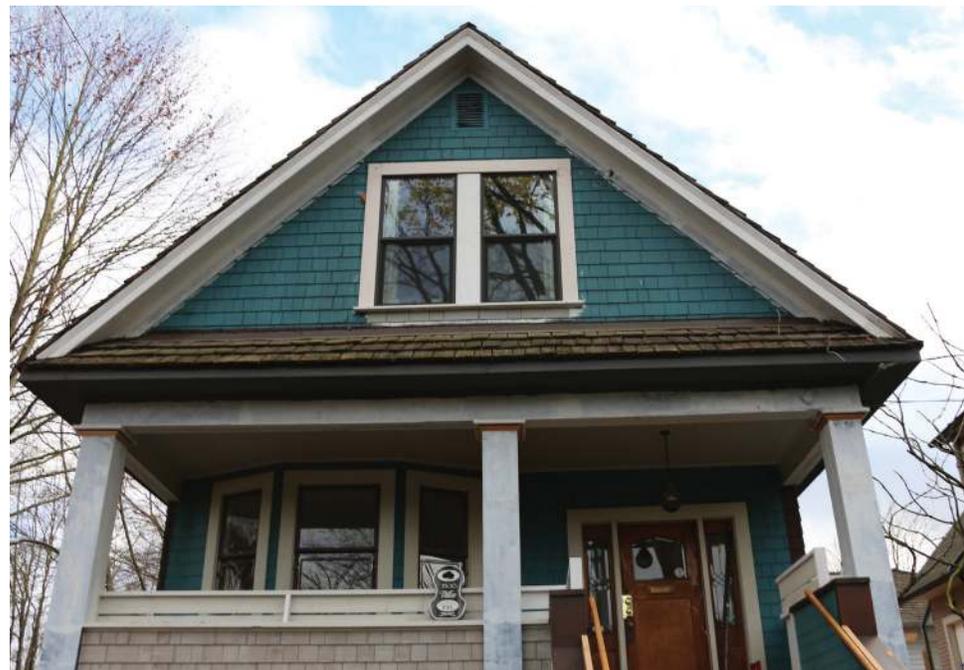
The infilled porch (left) was opened up during renovations to restore it to its original appearance (right).

features such as the wood floors that were uncovered in the renovation and the French doors that partition the main hall and the living room were retained. They also restored the porch which had been enclosed in a previous renovation.
