878 KEEFER STREET

Saving and expanding an historic Strathcona home

Researched and written by Katie Filek, Vancouver Heritage Foundation

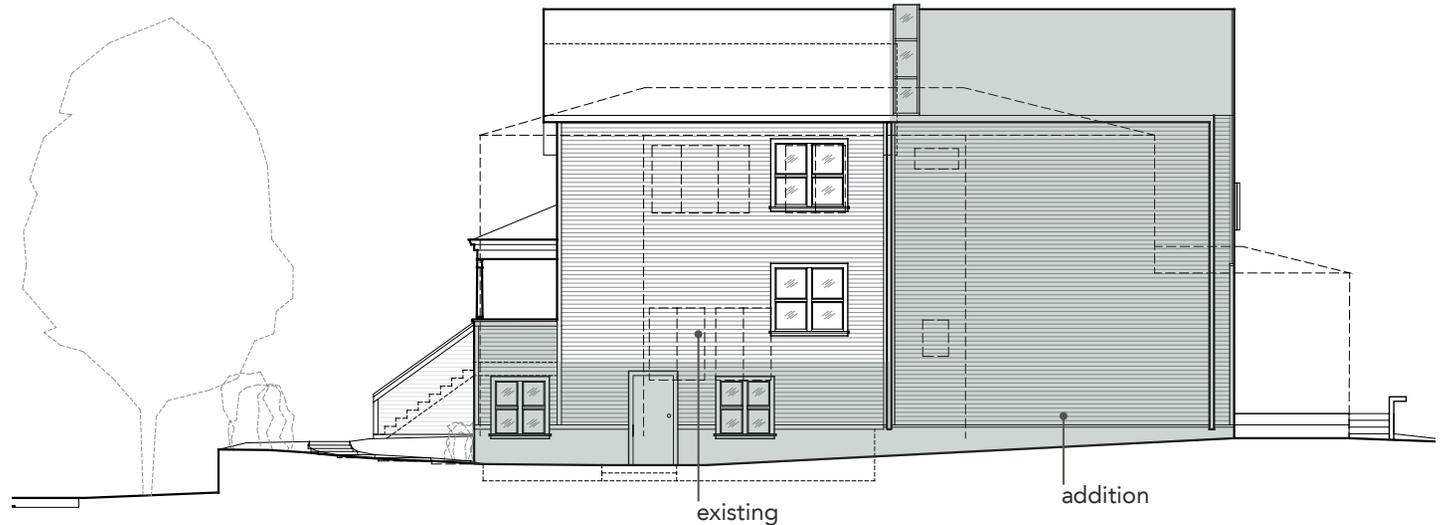
decorative fish-scale shingles in gable

original cedar drop siding

cedar flooring and original staircase with winders

Although not visible upon the purchase of the house, many original details of the home were revealed to be in good condition. A material connection to the home's origins is maintained through their retention.

defining elements of the home were, however, still intact: the original cedar flooring had been preserved under vinyl area rugs; the exterior drop siding and fish-scale shingles in the front gable were in excellent condition beneath the stucco; the old growth cedar trim of the interiors was highly salvageable; and the wooden staircase between the first and second floors was sturdy and in good repair. Knowing that it is such details that contribute to the historical and architectural significance of the house, Brian and Cheryl made the decision to

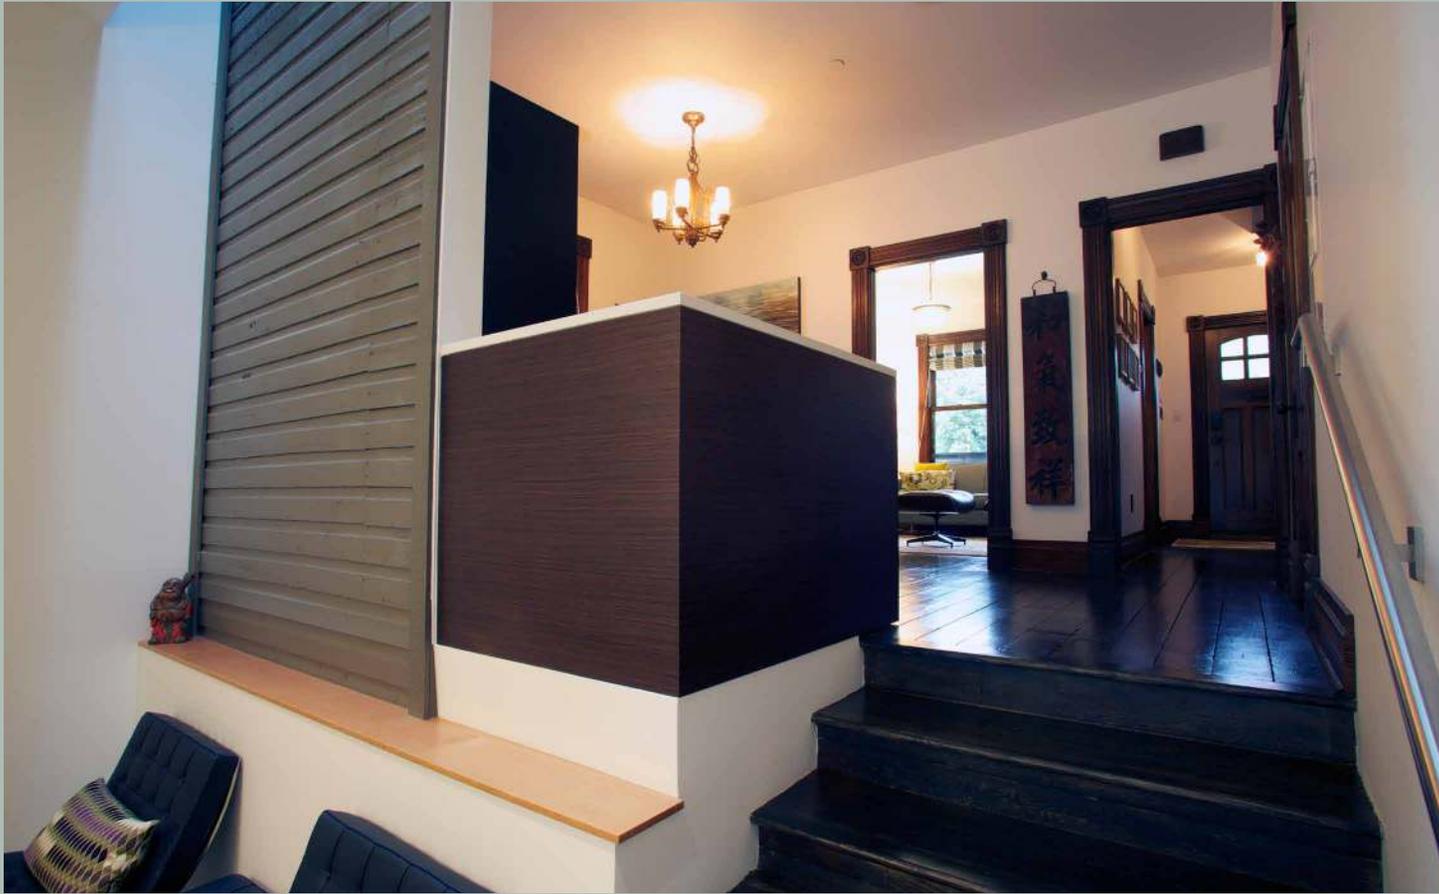
■ The interior transition from the original home to the modern addition. Much original material is visible, including the interior feature wall with its retained siding.

carefully and deliberately save these elements. This preservation of as much of the original fabric as possible (including the home's front façade, its massing and its setback from the street) allowed for the retention of an integral piece of Strathcona's architectural character. And although their rehabilitation included the construction of an entirely modern, 1300 ft² addition, the two-storey extension was built at the rear of the house, partially hidden yet visually continuous from street level. New siding was milled to match the original, creating

continuity. Even the raising of the house by 2½ feet to create room for a basement suite was done with care: the suite's entrance was placed off of the side yard, further preserving the character of the home's façade and its relationship to the surrounding streetscape. Each decision throughout the rehabilitation process was made with

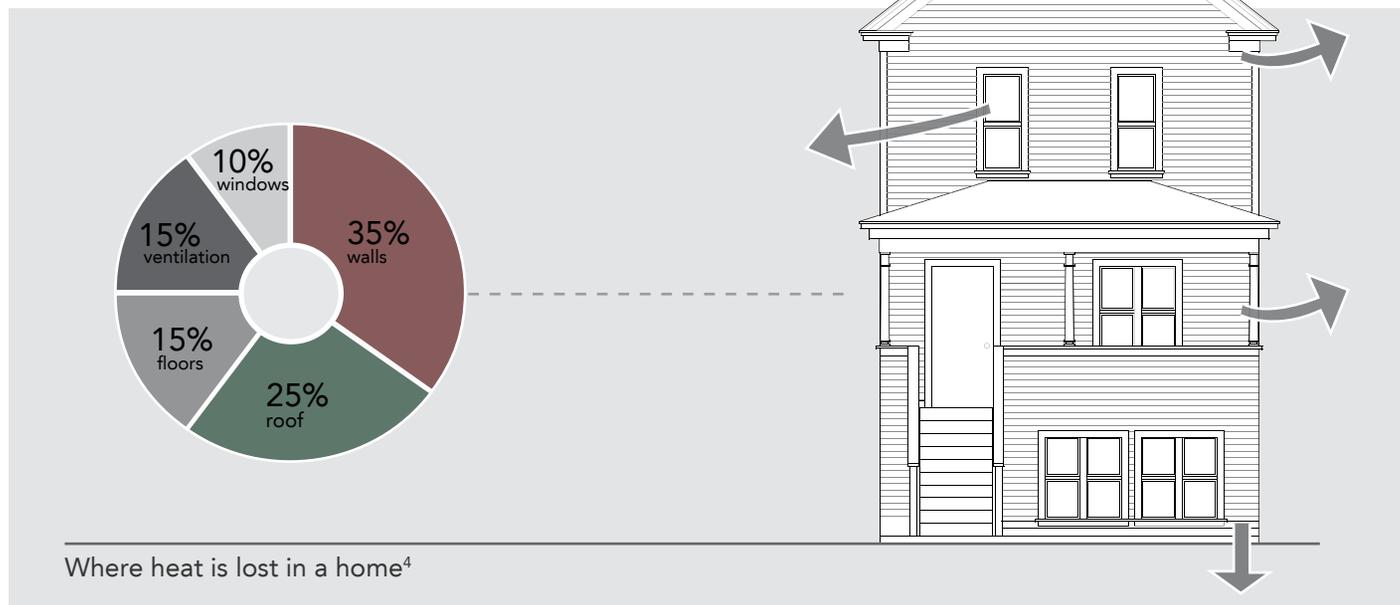
Old houses such as 878 Keefer St. (before the renovation) have a reputation for being “drafty” – and rightly so. Houses built up until the middle of the twentieth century were usually constructed without insulation, meaning that air can flow virtually unimpeded through the walls. Although this means a house can breathe and air out, it can also lead to uncomfortably chilly interiors and make it both difficult and expensive to heat interior spaces.

Rehabilitating a heritage home offers the opportunity to improve its energy efficiency in a major way. Insulating walls, roofs and foundations is an effective method of reducing heat loss through a home's thermal boundaries, improving its energy efficiency and making it more affordable to heat. On average, space heating accounts for 63% of a Canadian home's energy consumption (NRCAN 2008). In 878 Keefer St., much of

the energy expended would have been quickly lost through uninsulated surfaces. Adding insulation was therefore a logical and necessary step in bringing the house up to current energy standards.

As the project included removing the interior plaster and lath, which was degraded beyond repair, the walls were stripped to the studs. This allowed for the use of spray foam insulation to fully insulate the walls. The

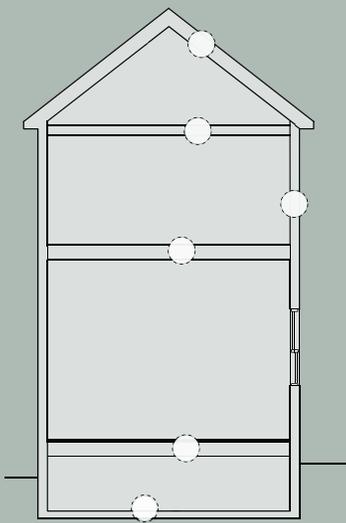
● where insulation was installed in 878 Keefer Street - walls, ceilings, floors, roof, foundations

flooring was left in place and worked from the exposed underside. In a less extensive renovation in which the studs remain covered, other methods can be used. Loose fill cellulose, for example, may be blown into covered wall cavities with specialized equipment. Different approaches to insulation do, of course, have both advantages and disadvantages, and the choice of which to use must be made on a case-by-case basis.

heat escaping a dwelling – 25% and 15% respectively¹. It therefore made sense in this situation to insulate not only the walls, but the ceilings and foundations as well. Once again, the extent of the renovation gave the capacity to do so. An air blower test was carried out before and after the renovation, showing an improvement from 48 air changes per hour to less than 2 changes per hour.

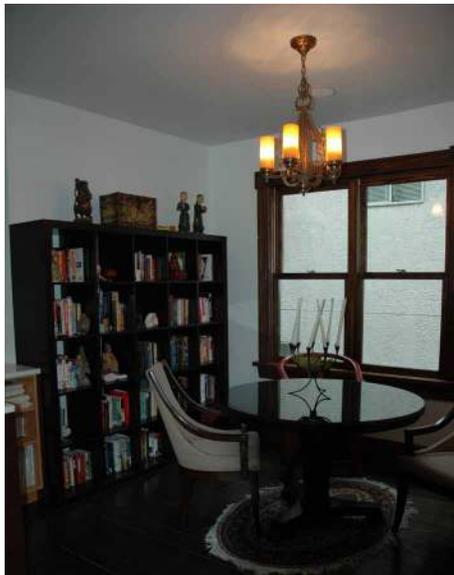
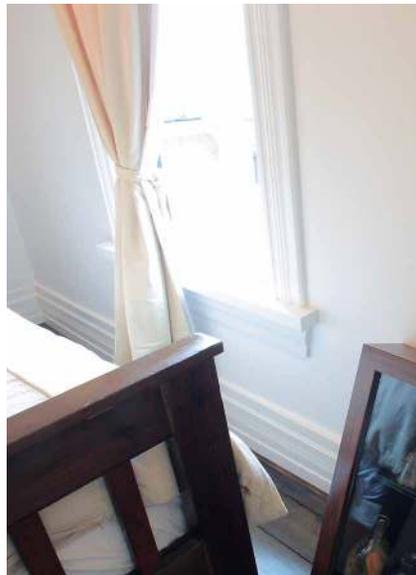
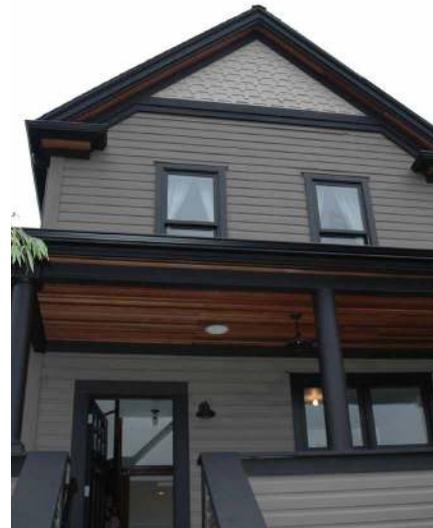
double-paned windows

■ windows with two panes of glass provide a more insulating barrier than a single pane, and can improve a home's thermal comfort and reduce noise transmission.

Many double-paned windows are filled with an inert gas such as krypton or argon, further slowing heat transfer.¹

low-E coating

■ low-E (low emittance) coatings are thin, virtually invisible metal or metallic oxide layers on glass. They help prevent heat from escaping through glass by reflecting radiant heat waves back into a building. Another type of low-E coating helps block heat from entering into a structure in hotter months.²

replacement double-glazed wooden windows with aluminum casing and low-E coating were used in this project

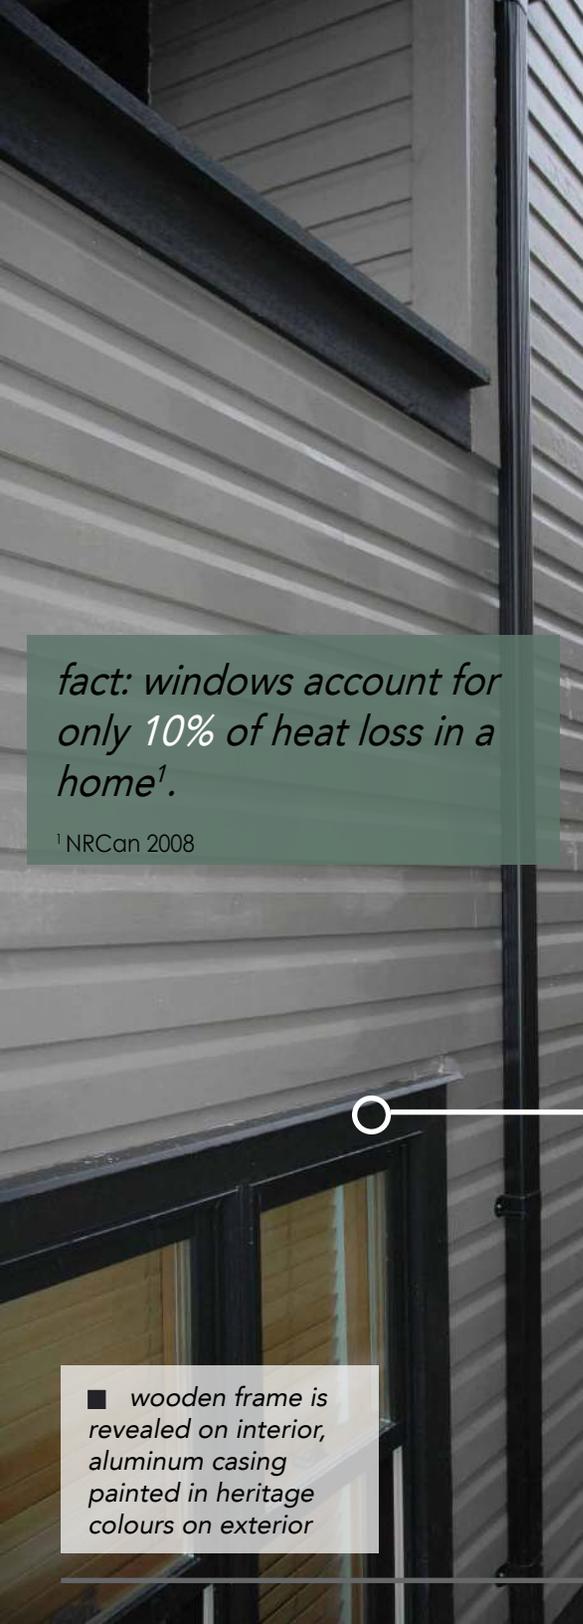
Retrofit options to increase energy efficiency

retrofit with interior panel

- mounting a panel on the inside of a single-pane window adds an insulating layer, increasing thermal efficiency and reducing noise infiltration
- panel can be glass, rigid plastic, or flexible plastic sheets

retrofit with exterior storm windows

- an exterior storm window protects the primary window from the elements and increases thermal efficiency
- may be permanent or temporary

retrofit with caulking and weather-stripping

- seal to prevent air leakage where window slides past frame
- seal where window casing meets wall

- use a strip of metal, foam, rubber or vinyl to seal window from the elements
- prevents moisture from entering in and interior air from leaking out

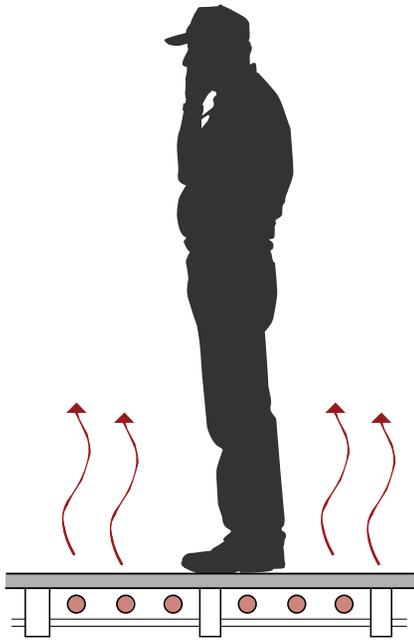
in-floor radiant heating

- heat rises from hot water running through tubes beneath the floorboards
- heat waves warm any objects they strike, producing an even blanket of heat
- can be up to 30% more efficient than traditional forced air heating systems¹

In-floor hydronic radiant heating uses hot-water tubes between the floor joists that radiate invisible waves of thermal heat, warming the objects they touch and providing an even blanket of heat throughout a room. Although ambient air temperatures are slow to change, the environment stays comfortable as the room's surfaces are warmed and aren't stealing heat from occupants' bodies.

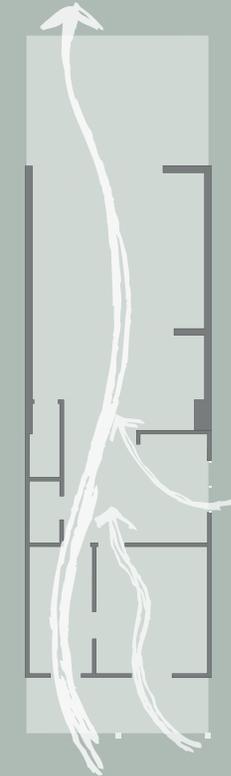
The use of natural ventilation, or air flow, to both cool and bring fresh air into a house is a passive design technique that has been used for centuries. It is often a feature of vernacular architecture.

In 878 Keefer Street, operable windows on opposite ends of the house allow for air to flow through the structure. This cross ventilation can cool bodies within the space and cool the home by removing hot air.

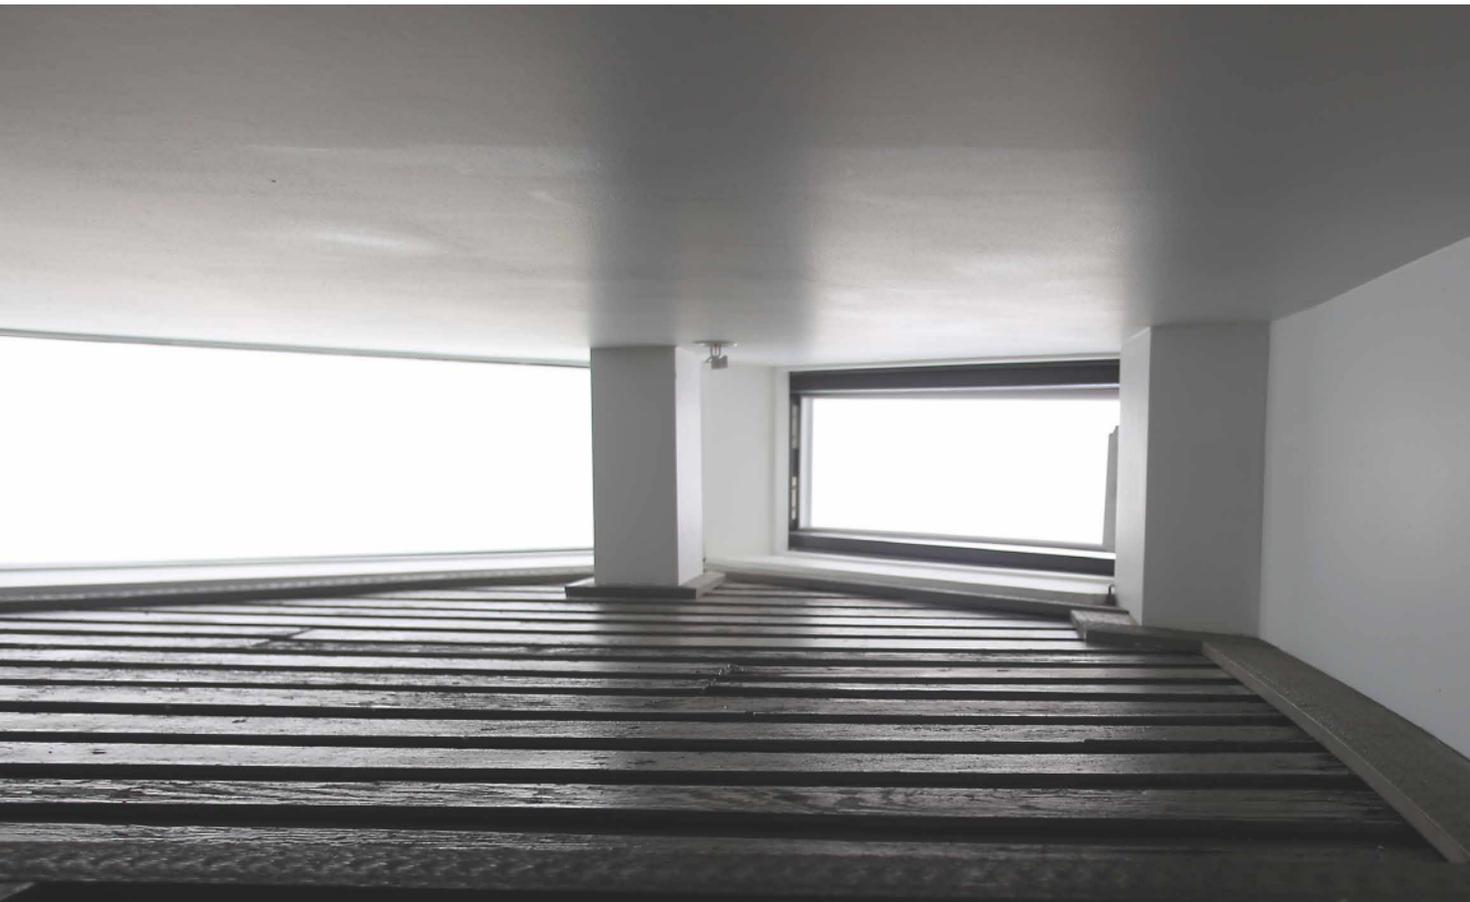
■ A remote that remains in the ground-floor kitchen allows one to open the skylight from a distance, creating an easily user-controlled environment.

Cheryl can control the indoor environment according to their comfort level. This reduces the need for mechanical systems and relies instead on passive systems to mediate air temperature. Additionally, the deliberate placement of the 2-storey lightwell between the historic house and the addition brings light into the centre of the home, reducing the need for electric lighting throughout the day.

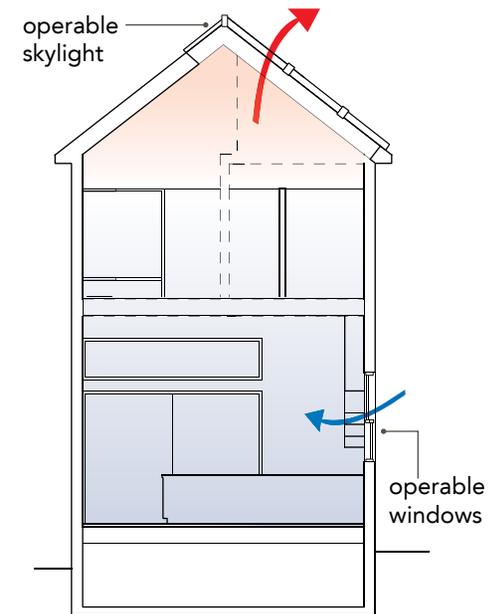
The Stack Effect

The operable skylight provides a natural and energy efficient alternative to mechanical ventilation through use of the stack effect. Warm, stuffy air moves naturally upward and escapes through the skylight while fresh air is consistently drawn in through windows below. The house is consequently ventilated and cooled.

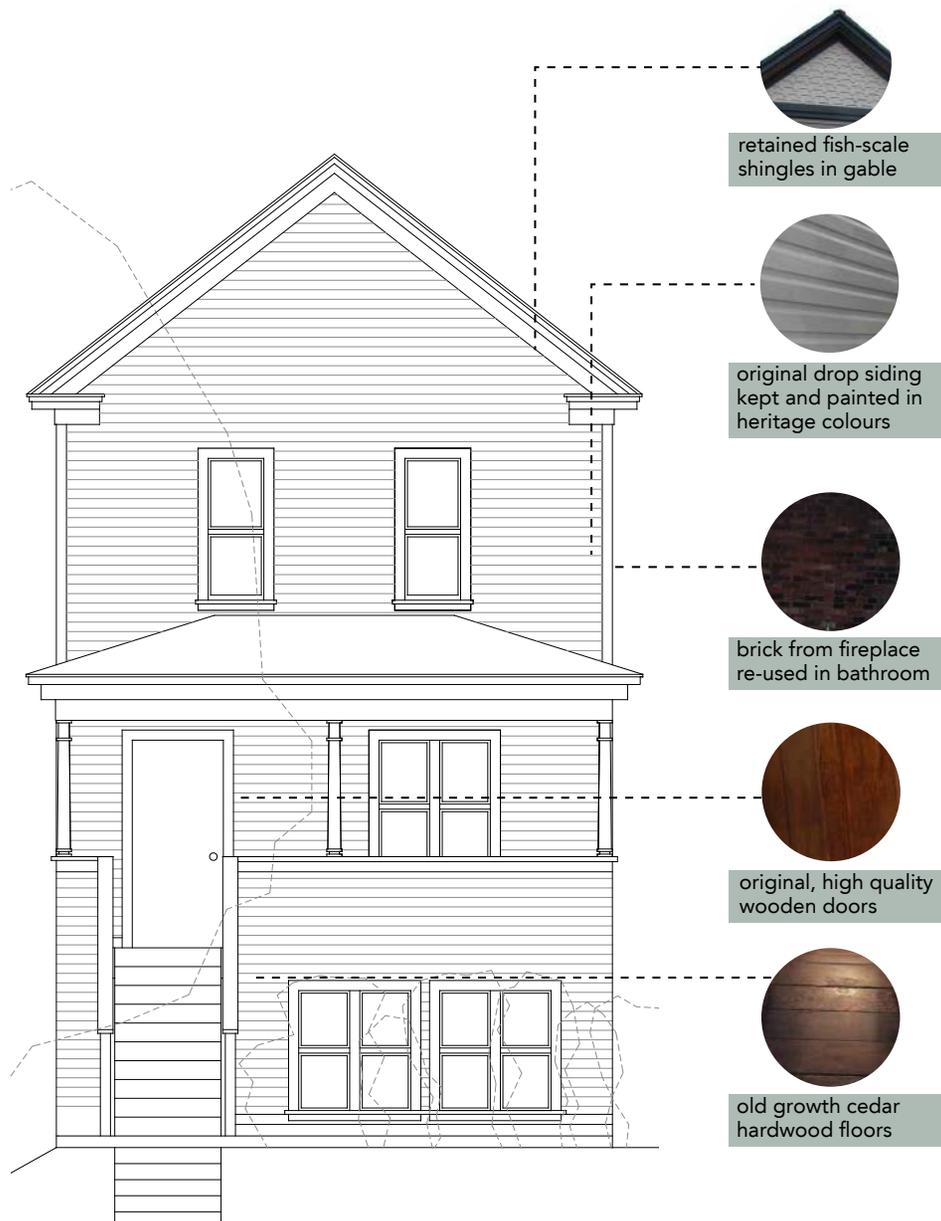
At the time of its purchasing in 2010, the home was sitting under

a heavy coat of stucco. Brian and Cheryl began by removing the stucco to reveal the original drop siding beneath, still in good condition. The siding on the new extension was made of cementitious Hardiboard siding and milled to match the original in appearance. Where the back of the home was opened up to meet the extension, a wall facing the kitchen was retained with its siding intact – a reminder of the home’s origins contained in its modern counterpart. The cedar flooring was retained in place along with the original cedar trim framing the doorways and the baseboards. In some cases the trim and moulding was missing or damaged beyond repair; when this occurred it was replaced with matching fir pieces. Brian notes that the craftsmanship and quality of work that was standard at the time of the home’s construction is sadly now unusual. As a developer with an eye for design, he is well aware that it is the details of a project that can make it successful. Brian therefore made certain that care was taken with any replacement pieces, and sought to ensure both quality and detail in replicating the pieces’ predecessors. Any new corner blocks of doors, for example, were first carved by hand, then placed in

a bag filled with rocks and shaken to match the aged appearance of the original 1892 corner blocks.

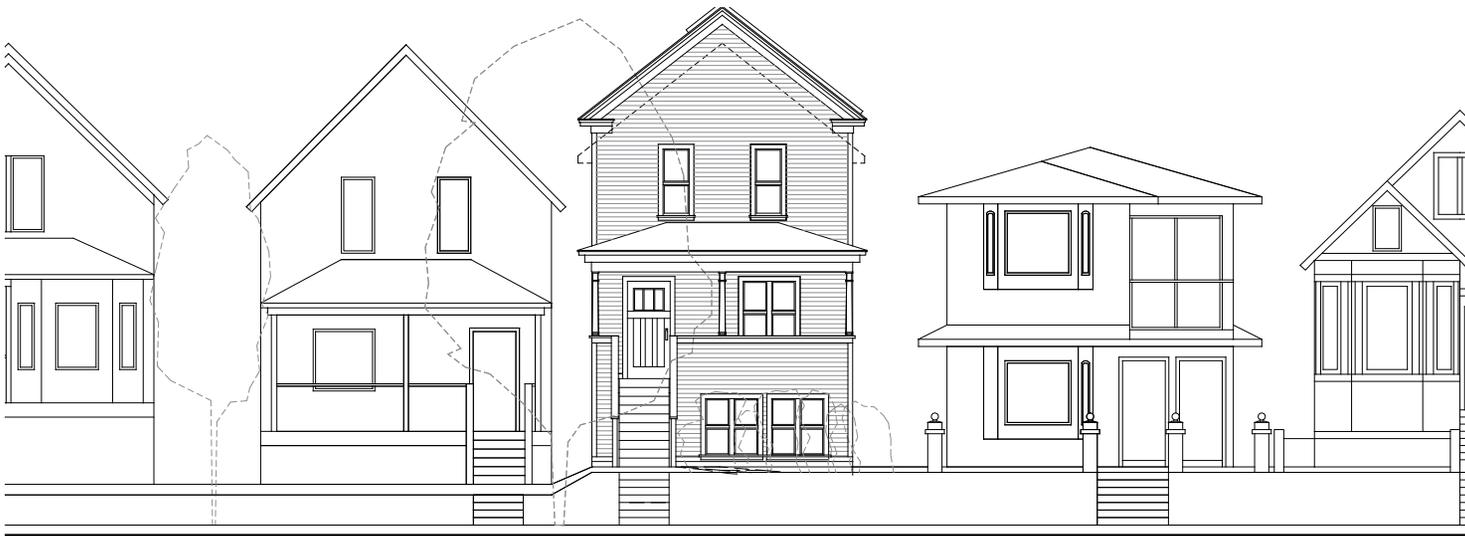
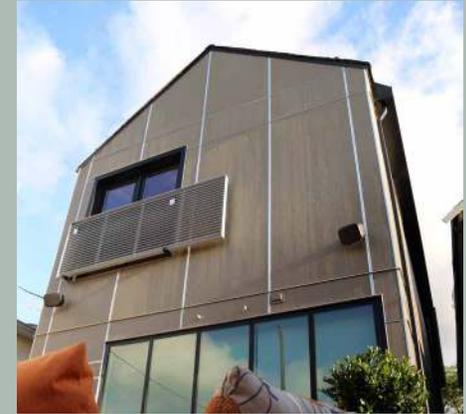
View of the house from the laneway, showing its sympathetic roofline and modern yet complementary materials

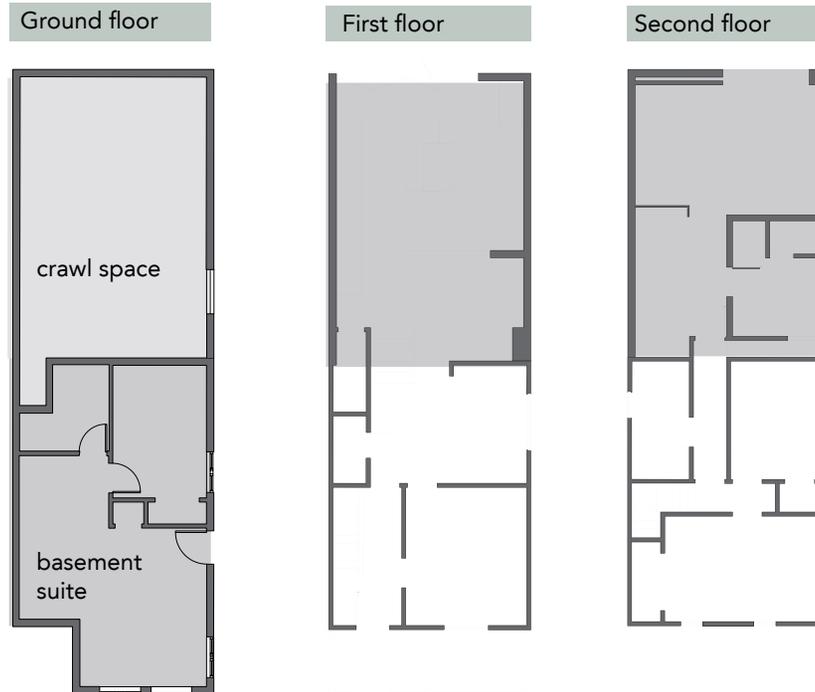
■ Floor plans showing 878 Keefer Street following its rehabilitation and expansion; spaces shaded grey are additions, those left white belong to the original house
