CARLETON HALL

Exploring the adaptive re-use of heritage

Researched and written by Katie Filek, Vancouver Heritage Foundation

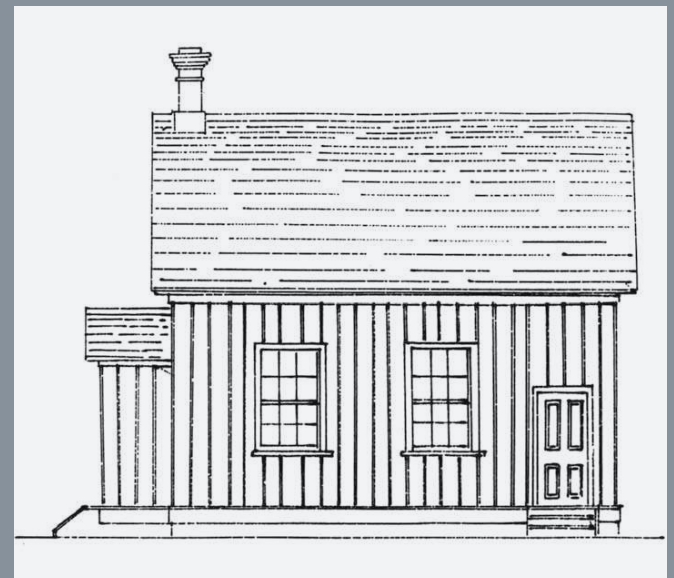
Drawing for an earlier version of a rural schoolhouse, issued in 1885 by the provincial government

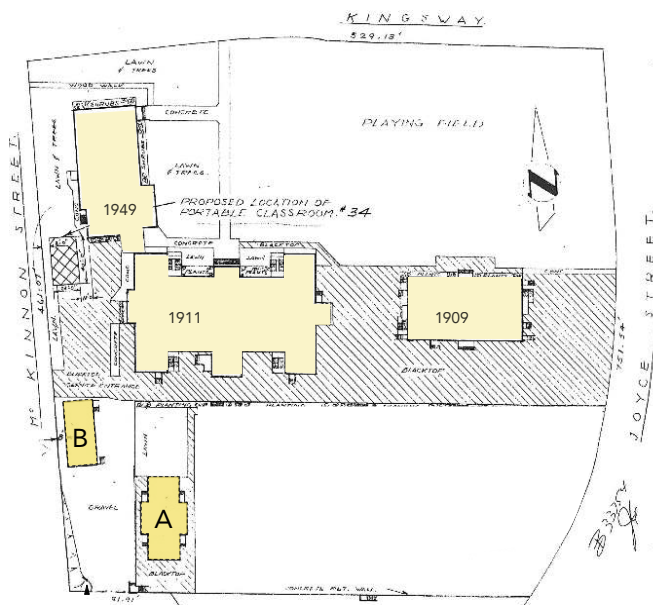
Plan of school site showing location of Carleton Hall (A) and the Barn (B) at the time of their rehabilitation

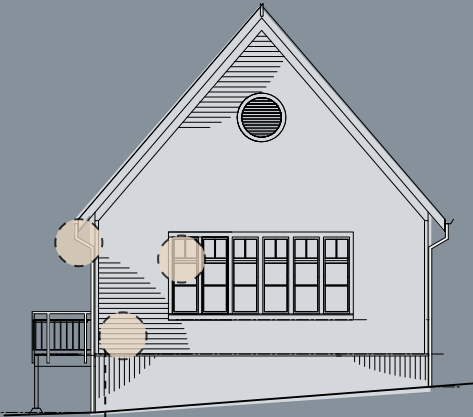
original wood drop siding

lathe-turned drop finials at ends of barge-board

double-hung wood sash windows, hidden behind boards

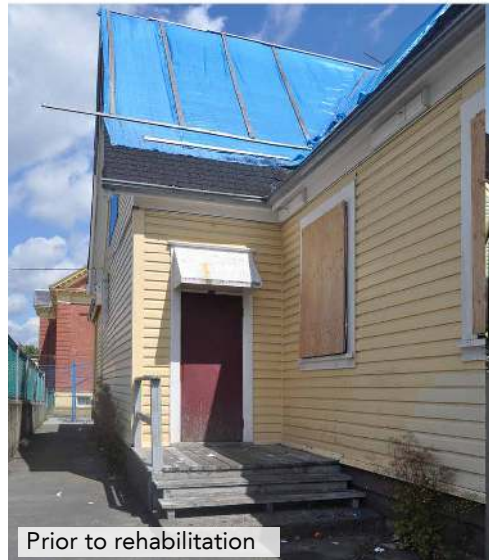
Prior to rehabilitation

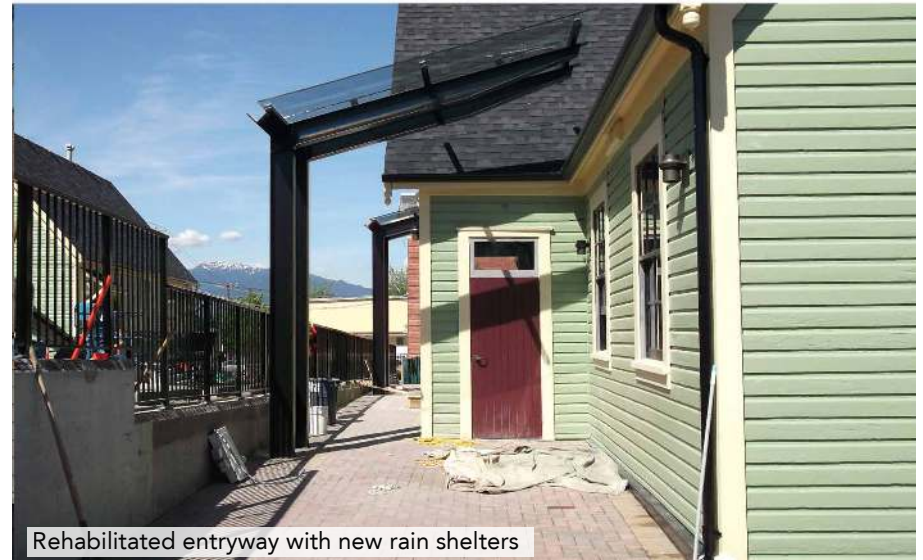
Rehabilitated entryway with new rain shelters

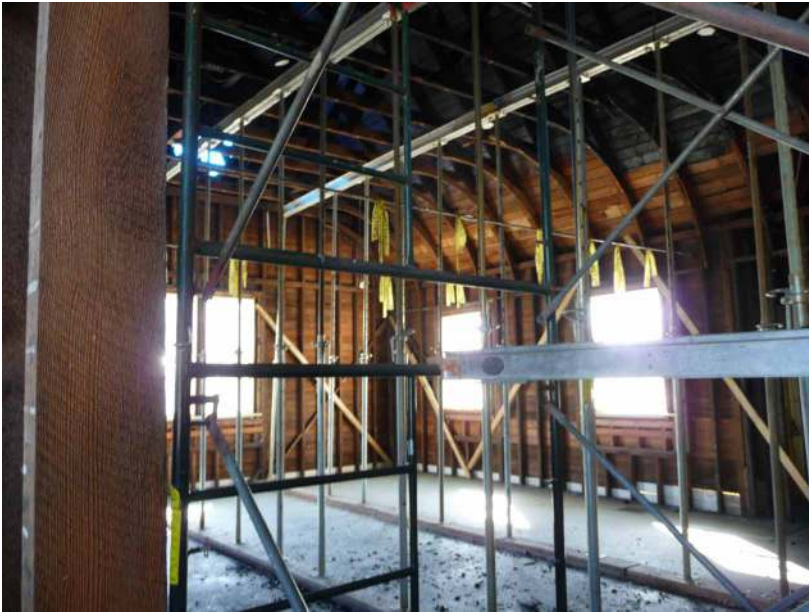
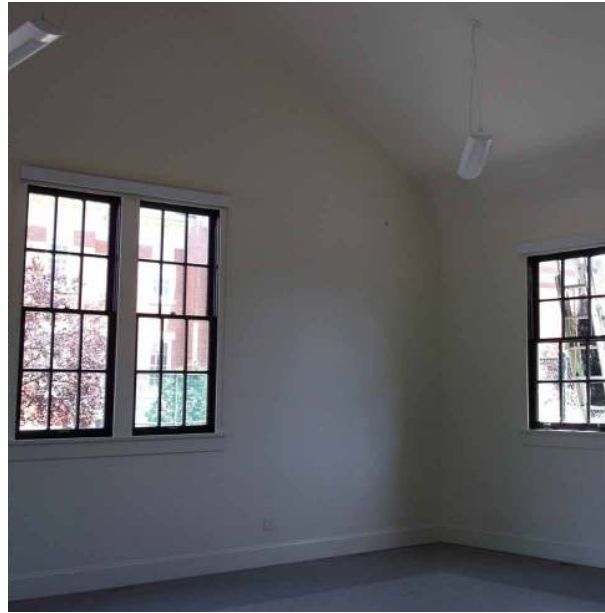
■ Left: Carleton Hall's interior prior to rehabilitation, with part of the roof missing and fire and water damage

■ Right: Interior of new rehearsal hall, with curved drywall to imitate curve of previous ceiling

roof was reconstructed with a new truss system, more modern than the simple wood frame structure that had existed before the fire. This led to certain challenges in matching the new roof to existing walls and maintaining a rainwater drainage system similar to the original. However, with patience and a touch of inventiveness this was achieved. Inside the building, the extent of the fire damage and subsequent efforts to clean up the damage meant that little remained. There were no surviving character-defining elements to conserve, and the focus was instead put on

creating functional spaces that would meet the programmatic requirements of Green Thumb Theatre. The interiors were therefore completely redone, with walls moved to create two separate rehearsal halls, an entryway, hallway, kitchen and bathroom. Dry wall and new laminate flooring was installed. Laminate flooring was deemed a suitable replacement due to the new intended use and acoustics required of a rehearsal hall.

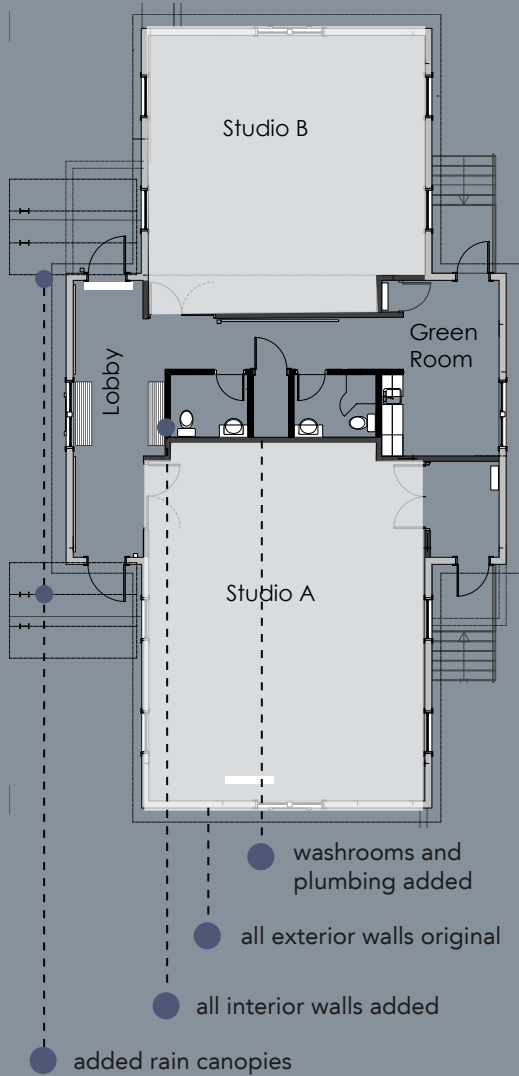
Carleton Hall: floor plan following rehabilitation for use as rehearsal halls

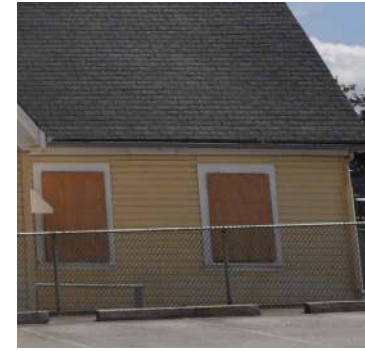
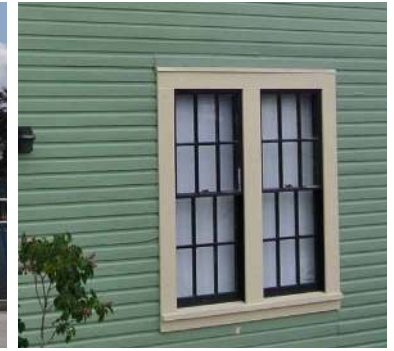
■ Carleton Hall's historic windows were retained and repaired

Although little character remained on the interior, the exterior components of Carleton Hall were found to be in good condition and able to be preserved (and restored where necessary). The traditional wooden drop siding is almost entirely original, with few replacement pieces. The windows – a mix of single and double-assembly, double-hung sash units – were not the originals from 1896, but had been replaced sometime after 1925. They were however similar to the originals, although shorter and lacking in a 6-paned transom, and the decision was made to retain these windows and their historic panes. The window frames were remediated to remove layers of lead paint (movement of the windows could lead to new paint rubbing off and exposing the lead paint beneath). The existing doors, replaced around the same time as the windows, were retained, with the door that had been in the vestibule returned to its original position. The only decorative elements of the building were a set of lathe-turned drop finials that embellished the ends of the bargeboards: the majority of these were in place and were preserved and stabilized, and the three finials that were missing were restored with matching lathe-turned profiles.

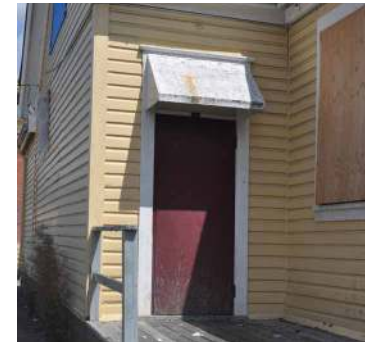
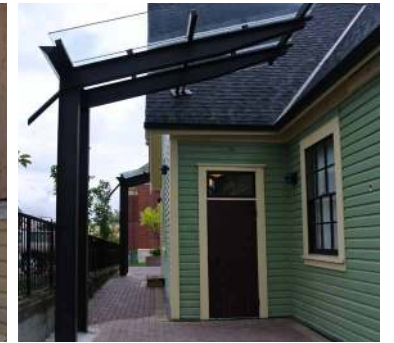
■ Rehabilitated entrance of Carleton Hall with added rain shelters

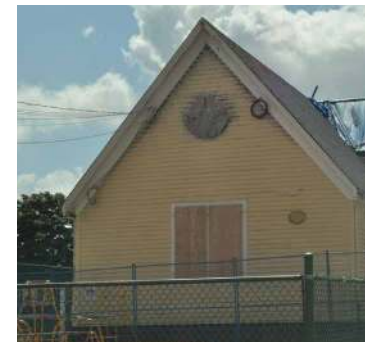
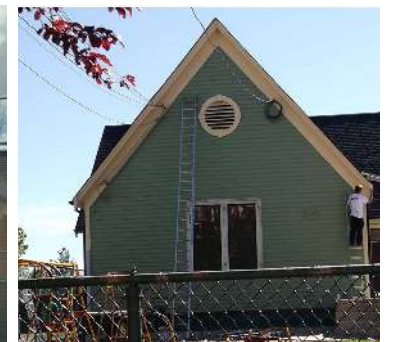
■ The form and cross-gable roofline of Carleton hall was maintained, staying true to its original heritage character

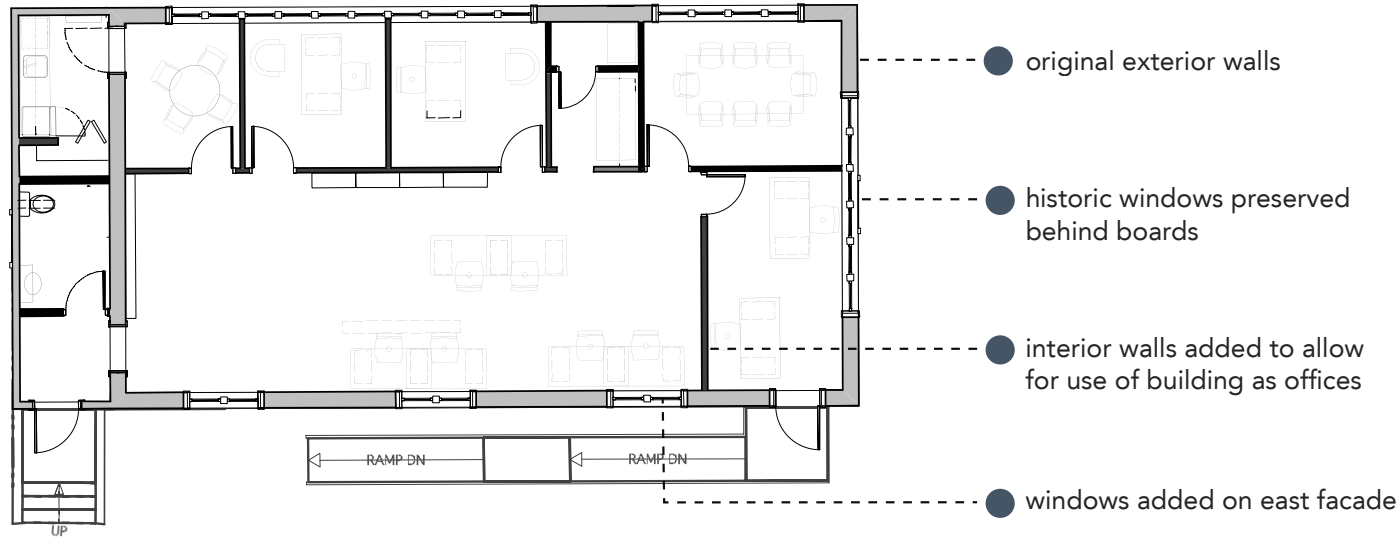
The Barn: floor plan following its rehabilitation and reconfiguration as office space. The open plan of the original one-room school house allowed for its division.

— added wall
— existing wall

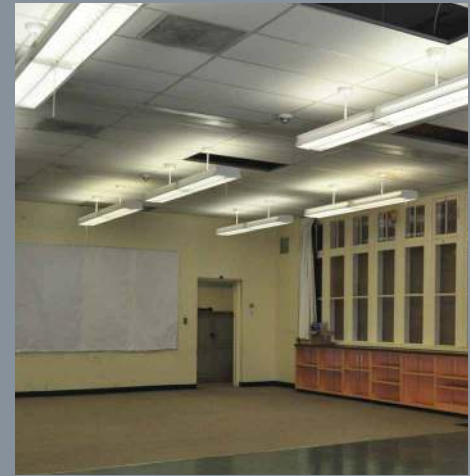
■ Interiors of the Barn prior to rehabilitation

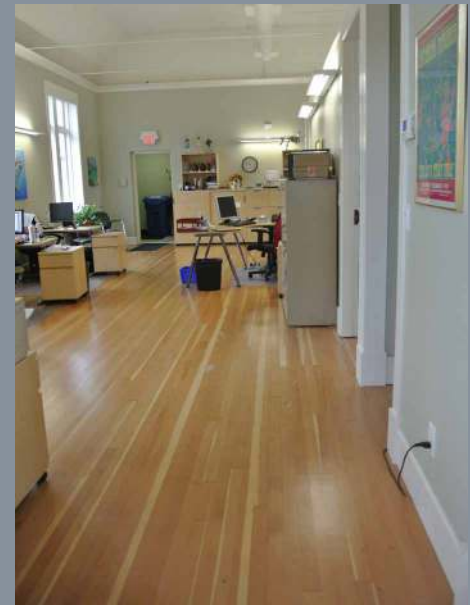
■ Finished and reconfigured interiors of the Barn, with drop ceiling removed and original wooden flooring in place

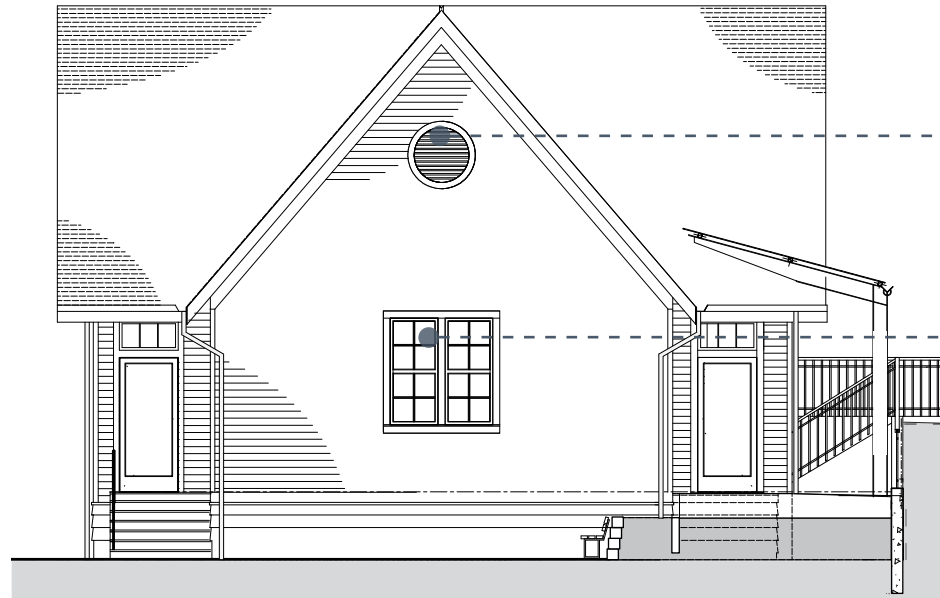
inherently sustainable elements

the louvered gable vents on either end of both buildings allow for natural ventilation

maintaining the operable windows and transoms allows for user-controlled environments and cooling, and reduces the need for mechanical systems

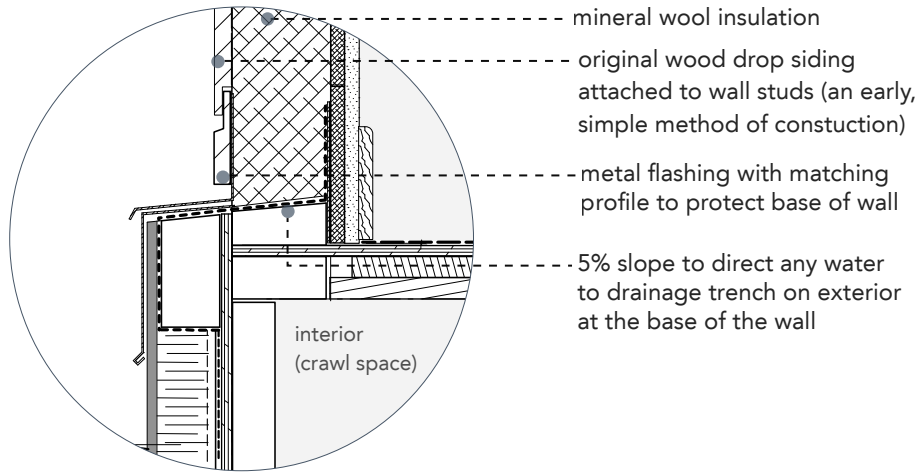
■ Wall detail showing drainage system where wall meets foundation
Drawing courtesy of Cornerstone Architecture

Increasing the insulation of the buildings presented a greater challenge. The buildings' exterior cladding did not have a rainscreen in the way that the exteriors of today's buildings do, but instead was built to shed water and to allow both moisture and air to pass through the walls. This meant that historically the buildings were able to dry out in the case that moisture did enter into the wall cavity, but also that certain types

of insulation were not suitable for use in retrofitting. Spray foam insulation, which has a high R-value, would typically have been the first and simple choice for insulating the walls. In this case, however, spray foam insulation would have trapped moisture in the wall cavity and could have eventually led to mould, rot and decay. A mineral wool insulation was chosen instead that could wick moisture away, down to an inventive drainage detail at the bottom of the wall. It was a solution that took consideration and collaboration between the

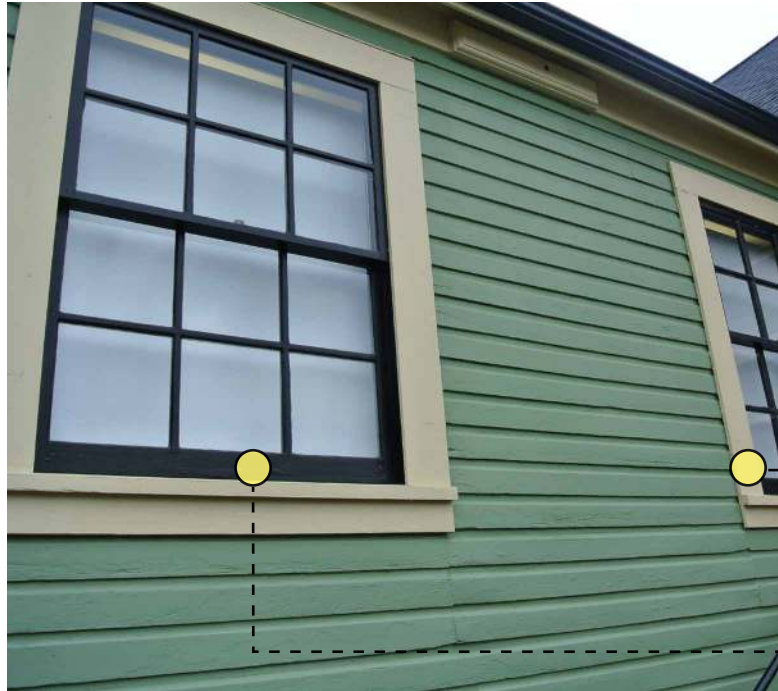
historic photographs revealed that the existing windows were not original but added sometime after 1925; however, they were preserved as part of the building's history

historic glass panes were retained where possible and single pane replacements were installed if necessary; wood frames were repaired

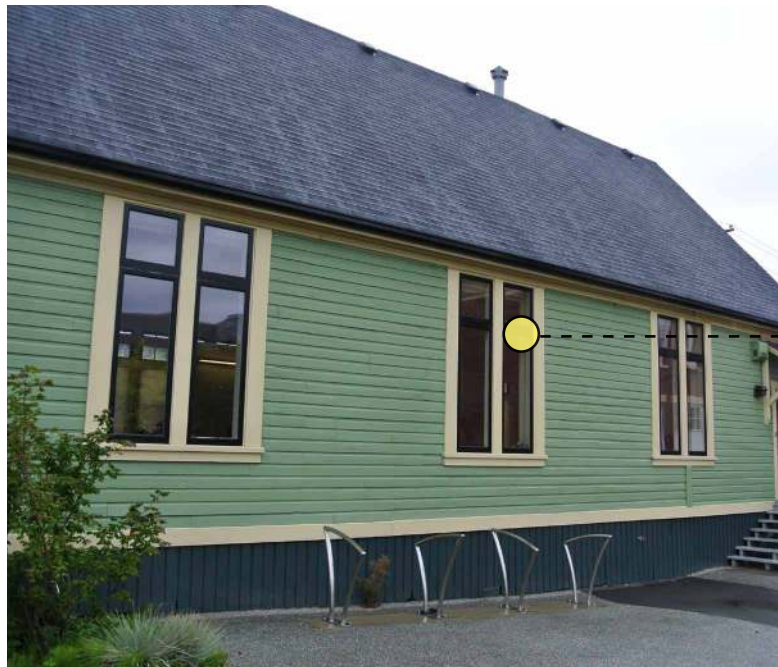
new, double-glazed window units were added to the east façade of the Barn, which had previously been free of windows to allow for blackboards

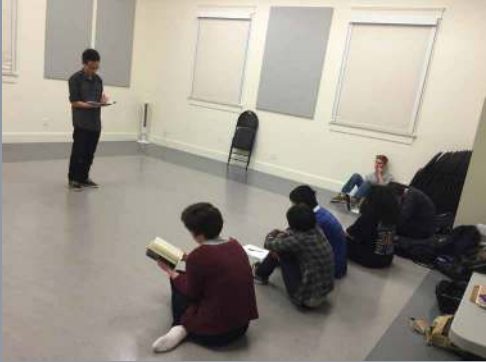
Above: Students involved in Green Thumb's Edge Academy (a project in which 12 teen actors develop a play from start to finish) work in the transformed space of one rehearsal hall.

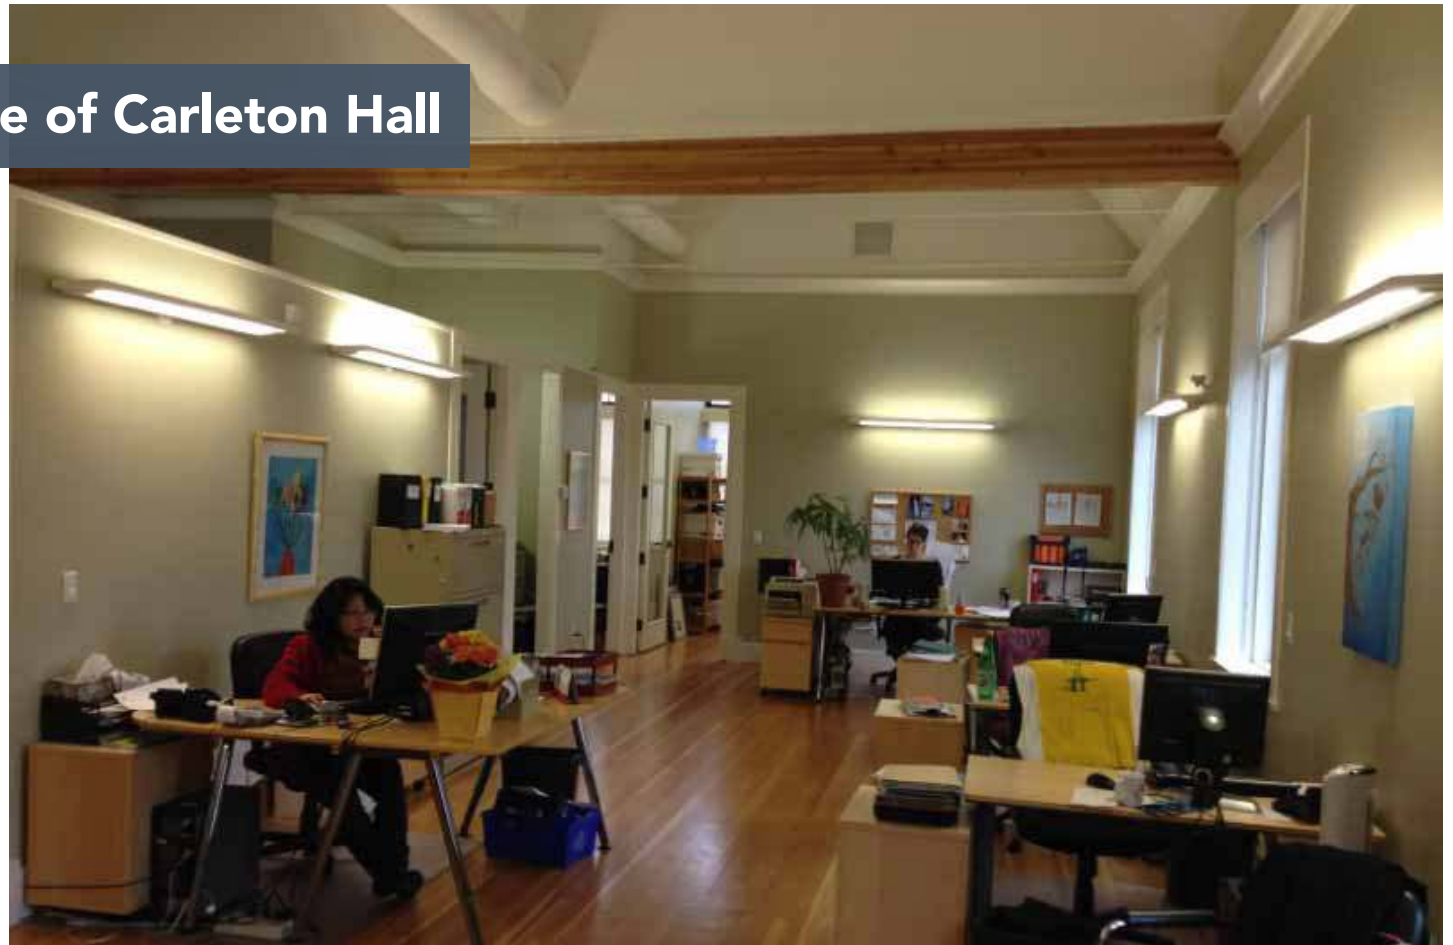
Right: The open plan at the one-room schoolhouse allowed for its transformation into office space.

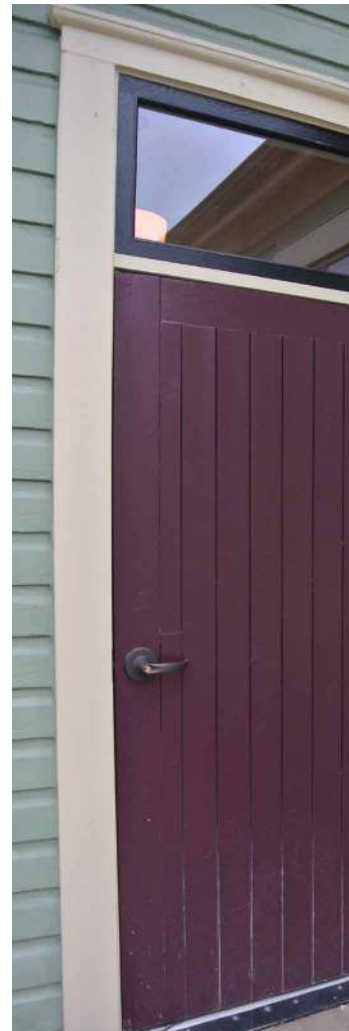
Maintaining an historic colour palette

A paint chip analysis was carried out to identify what colours the two school buildings would have been originally painted. This analysis revealed that siding would have been a deep red, doors would have been green, and trim, ivory. Green Thumb chose to remain within this historic palette but adapt it to their personal branding and preferences.
